Name Of Dam: SMITHLEIGH DAM  
Location: AUGUSTA COUNTY, VIRGINIA  
Inventory Number: VA. NO. 01523

# PHASE I INSPECTION REPORT NATIONAL DAM SAFETY PROGRAM

SCHNABEL ENGINEERING ASSOCIATES, P.C./  
J. K. TIMMONS AND ASSOCIATES, INC.

JULY 1980

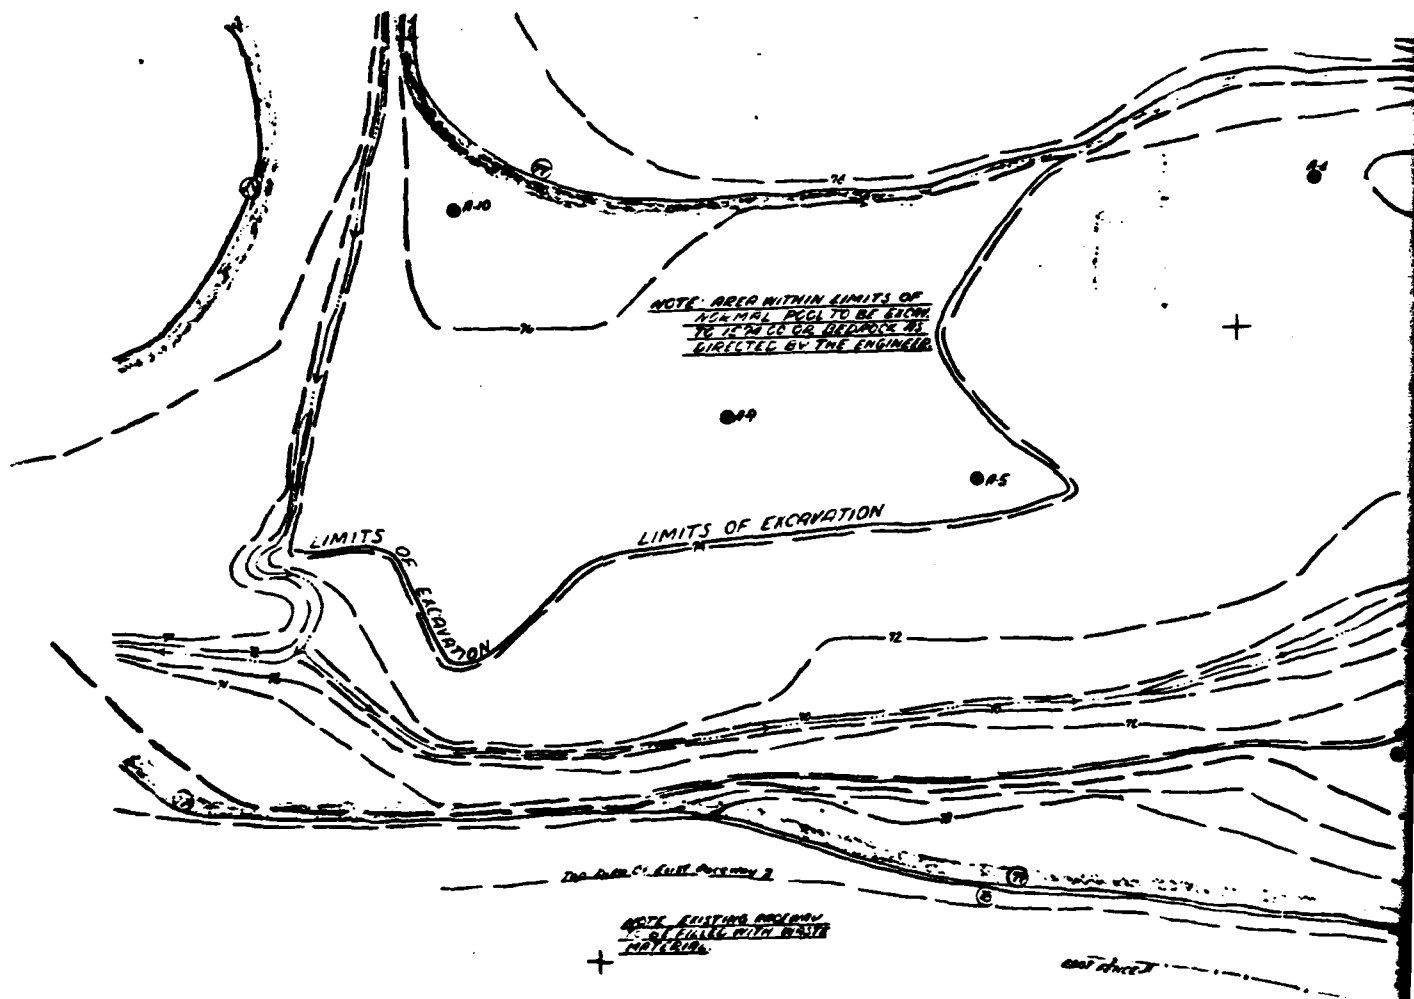
PLATE NO 2  
SHEET 1 OF 4

A subsurface investigation was conducted at the site by E. O. Gooch and Associates during the initial design stages. The investigation consisted of drilling 13 auger probe borings to obtain bulk samples and 7 test borings including standard penetration tests. A report of the investigation with foundation recommendations was prepared based upon geological reconnaissance, test borings, and laboratory soil testing. Boring logs are included as Appendix IV and their locations are shown on Plate No. 2 of Appendix I.

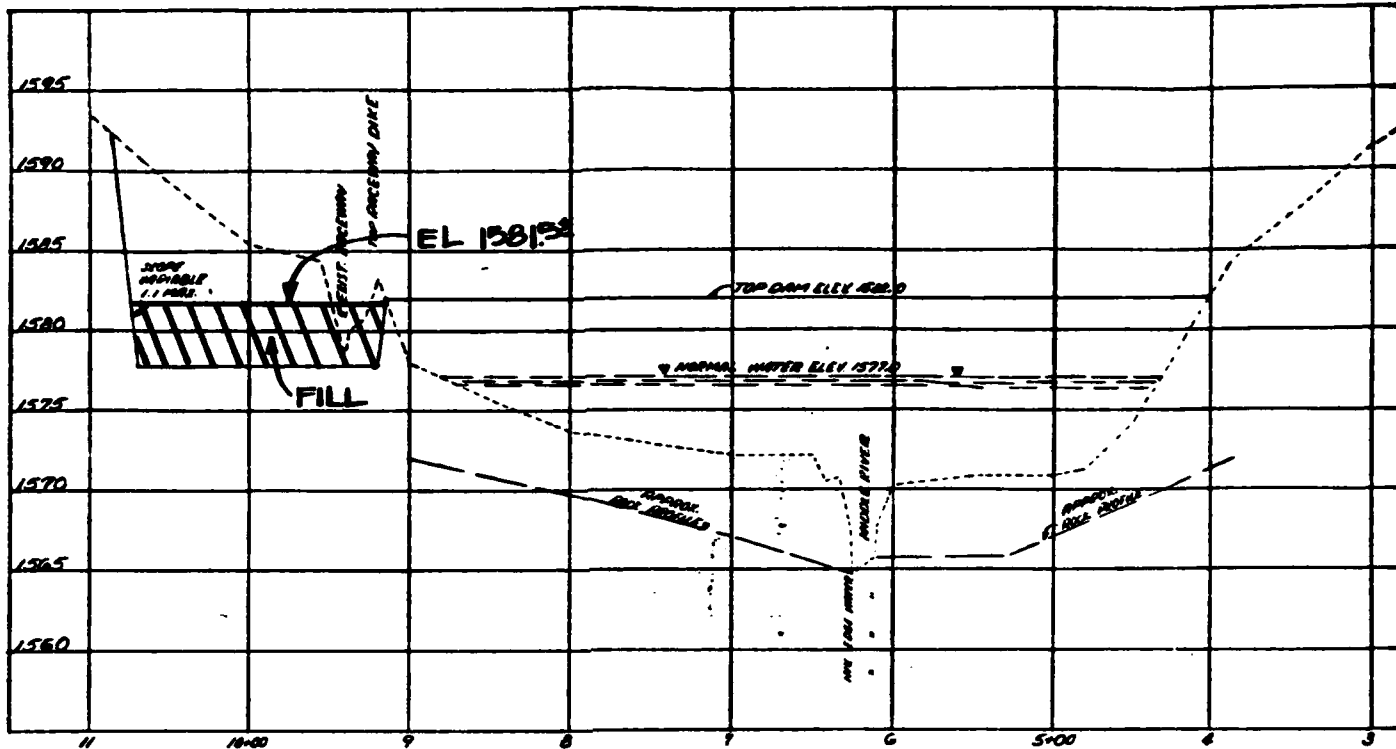
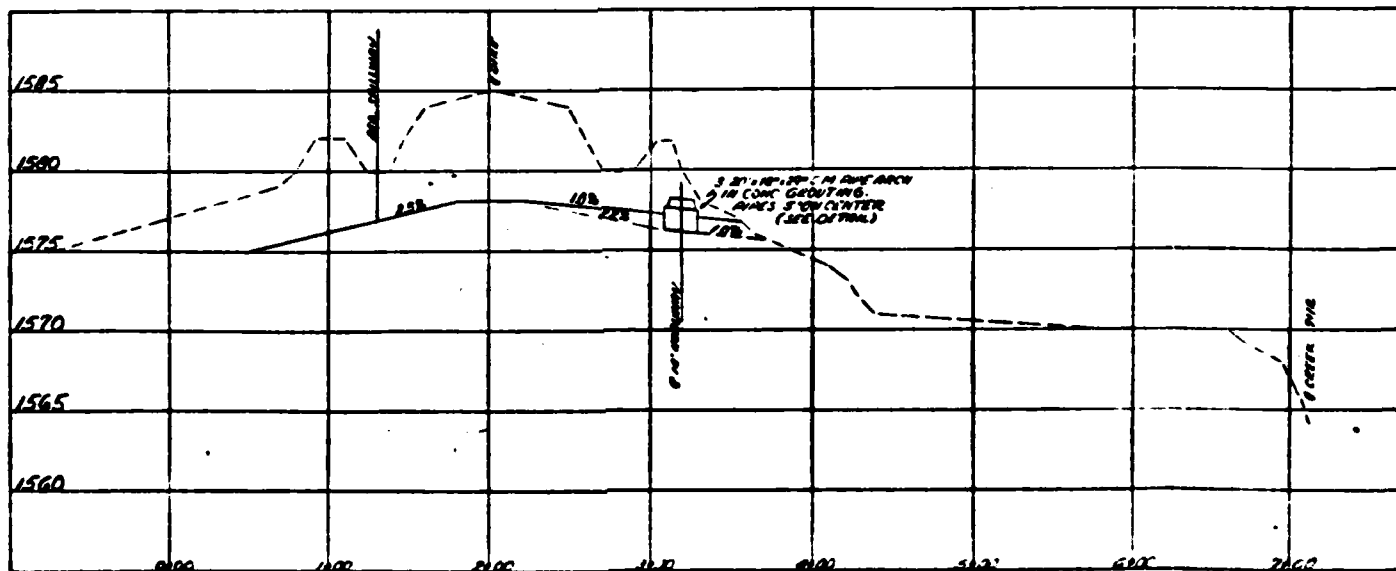
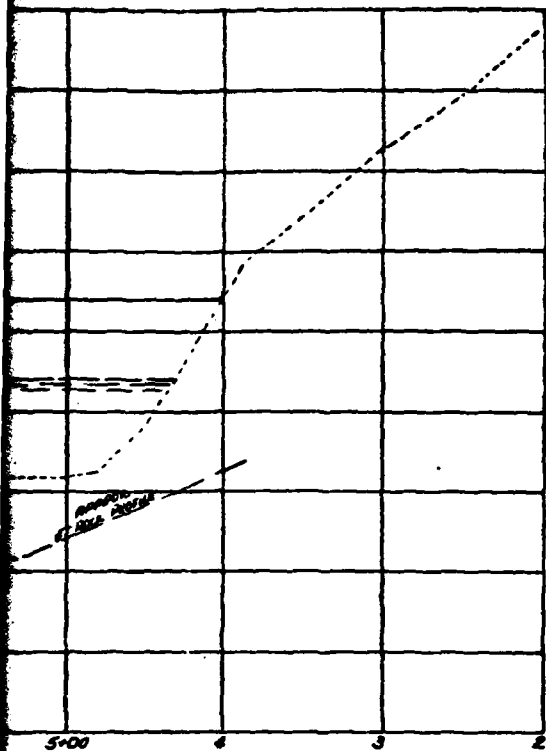
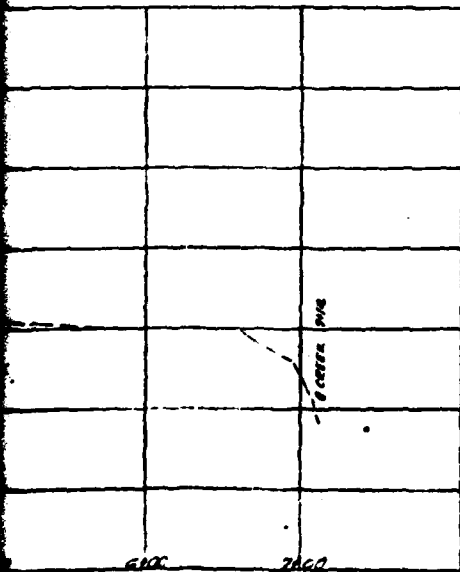
PLATE No 3

The dam is a zoned, compacted earthfill embankment (Plate No. 3, Appendix I.) The upstream slope is 3 horizontal to 1 vertical above elev 1577 and 2 horizontal to 1 vertical below elev 1577. Eighteen inches of stone riprap exists between elevations 1576 and 1579. The downstream slope is 6 horizontal to 1 vertical. Zone I was to be constructed with soils excavated from the emergency spillway, while remaining materials from the emergency spillway and soils

A review of design drawings (Plate No. 3, Appendix I) indicates the dam is founded on overburden and includes a 10 ft wide cutoff trench which extends to bedrock. Test borings encountered limestone bedrock at depths of 4 to 5 ft below ground surface in the flood

The principal spillway consists of a concrete riser and 36 inch diameter concrete outlet pipe, which extends through the structure. Four anti-seep collars or "watertight diaphragms" were provided in design, spaced 22 ft on center (Plate No. 3, Appendix I).

6.2.1 Materials: The dam was constructed in 1968 as a zoned structure; however, basically the same quality silty clay (CL) and clay (CH) soils were used in both Zone I and Zone II, (see Plate No. 3, Appendix I). The distinction in zones was basically only related to the higher compaction requirements specified for Zone I. Therefore, the dam is considered a modified homogeneous dam with respect to stability. It could not be determined from the construction specifications whether compaction was in accordance with ASTM Standard D-1557 (modified proctor) or ASTM Standard D-698 (standard proctor).

6.2.2 Subdrains and Seepage: Design drawings (Plate No. 3, Appendix I) indicate the presence of a drainage system under the downstream portion of the embankment. Filter material consists of well graded bankrun sand, silt, and gravel. The drainage system is apparently functioning properly, as no seepage was encountered during the inspection. No foundation drains were observed during the inspection; however, Mr. Cox recalled seeing several when there was no flow in the concrete outlet channel.

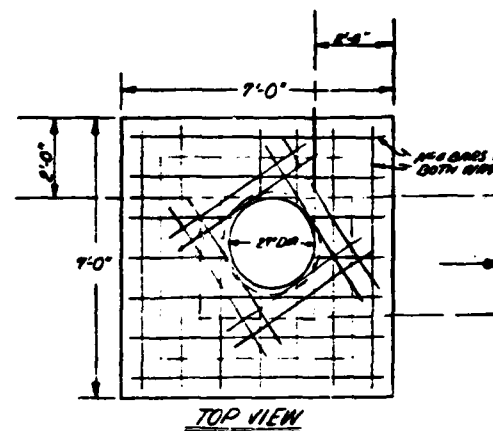
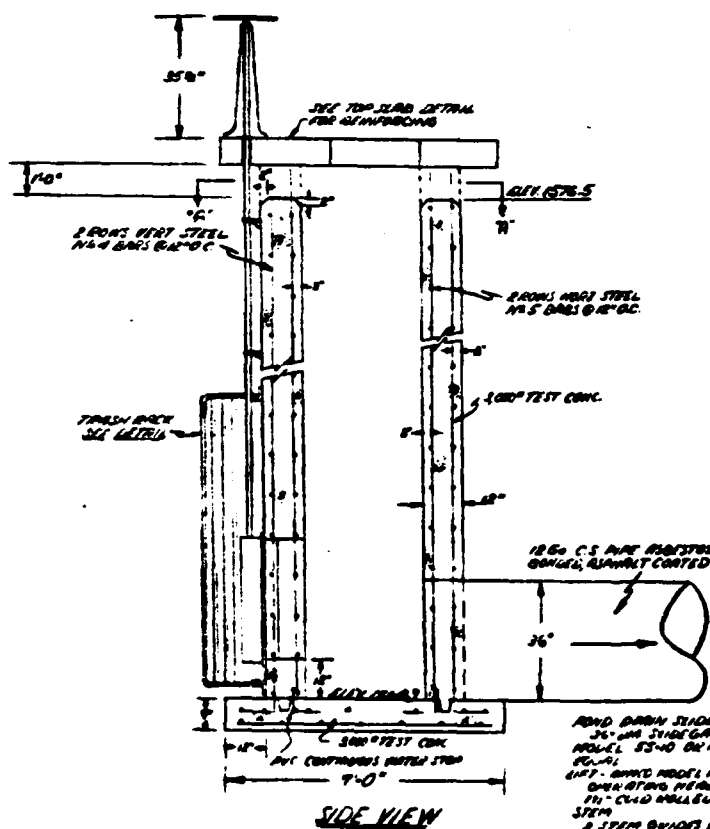
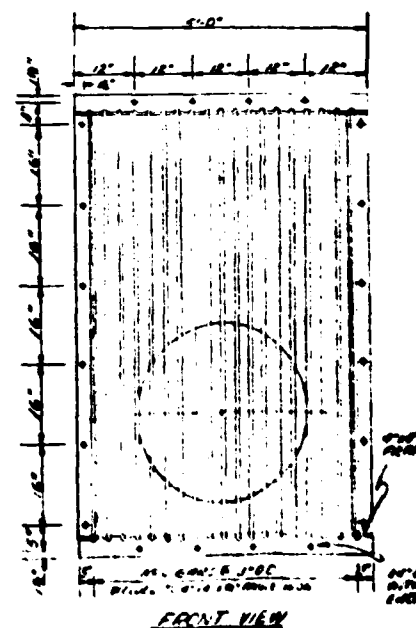
PLATE N°4  
SHEET 2 of 2

An emergency spillway was originally constructed in the right abutment as shown on Plate No. 4 of Appendix I. According to the Owner this emergency spillway was subjected to continual erosion, therefore, in 1977 the spillway was raised and an additional emergency spillway constructed. The original emergency spillway is now a 210 ft wide grass-lined earth channel with 1.5:1 side slopes. The new emergency spillway which was designed by Mr. R. R. Smith, consists of five 44 inch x 72 inch corrugated pipe arches with a concrete discharge channel (Plate No. 6, Appendix I).
